SUBJECT: Calvert Cliffs Nuclear Power Plant  
Unit No. 1; Docket No. 50-317; License No. DPR 53  
Licensee Event Report 94-007, Revision 01  
Reactor Trip Caused by Closure of Turbine Stop Valves

## LICENSEE EVENT REPORT (LER)

TITLE (4)  
Reactor Trip Caused by Closure of Turbine Stop Valves

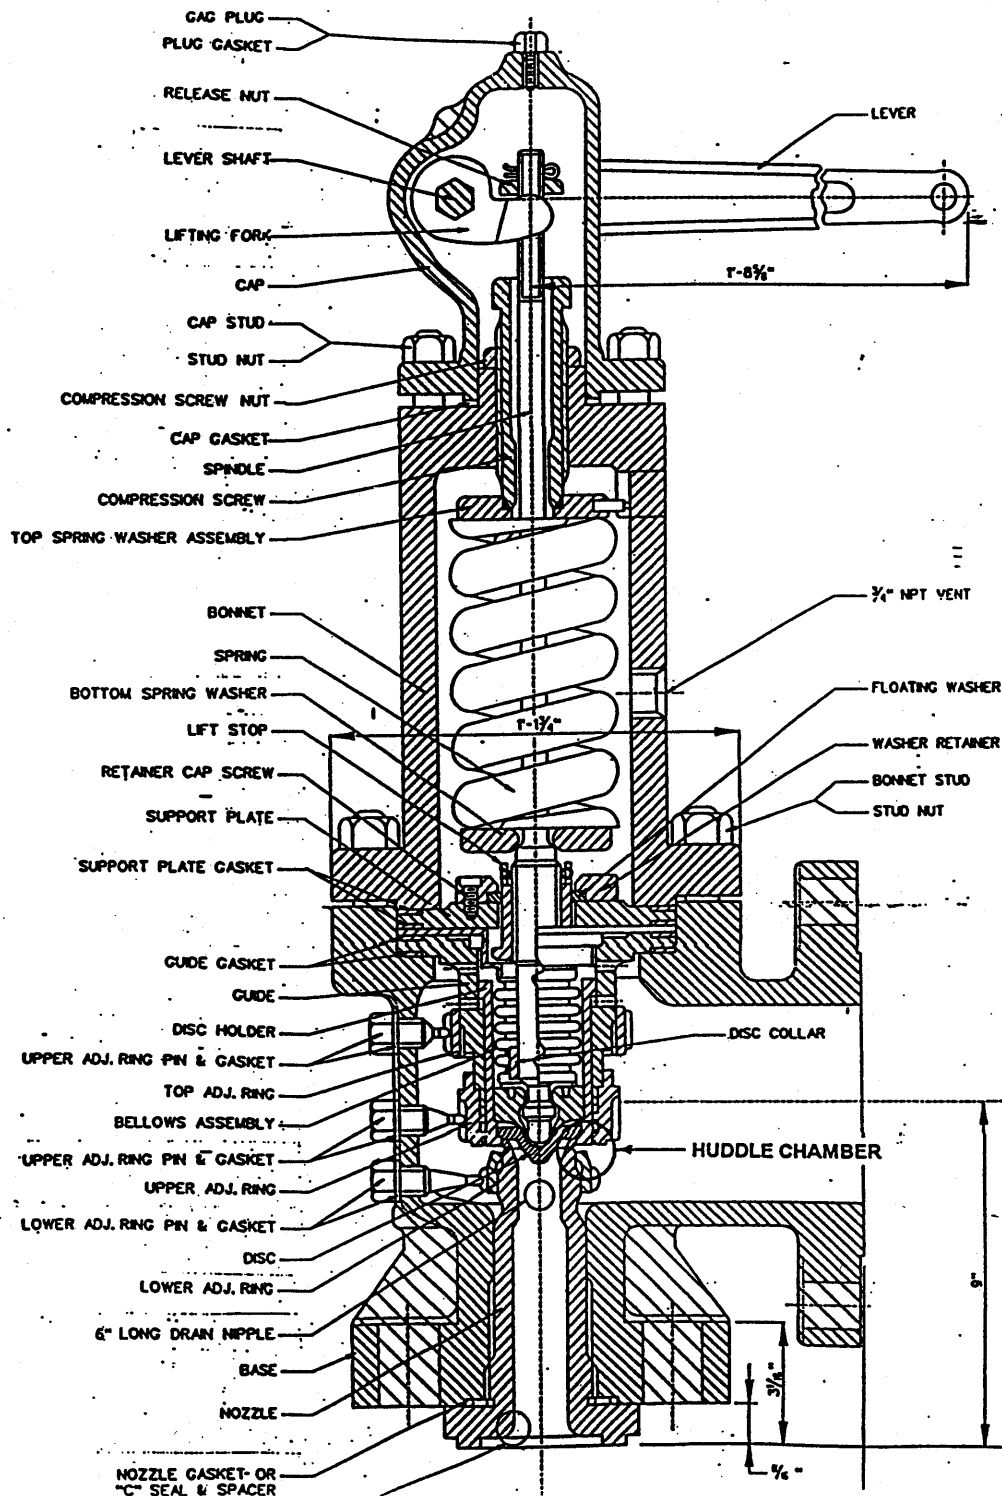
FIGURE 1

Based on the hardware root cause analyses conducted on RV-201, the cause of the premature lift was determined to be an improperly staked disc holder (see Figure 1). This disc holder was improperly staked to the bellows assembly, allowing the disc to rotate and drift downward toward the lower adjusting ring. This valve specific deficiency effectively lowered its setpoint when subjected to other contributing factors such as valve leakage, elevated RCS pressure, and flow-related vibration created by opening of 1-ERV-404.

The cause of the subsequent RV-201 leakage was that the valve failed to properly reseal after the lift transient due to damage and misalignment of the valve's internal components resulting from the valve lift and/or flutter occurring during the transient. Valve "flutter" is a rapid reciprocating motion of its internal parts in which its disc does not contact the seat.

- The valve manufacturer has initiated improvements to the disc holder/bellows assembly staking process to ensure that appropriate quality assurance methods are in place to prevent recurrence of this problem.

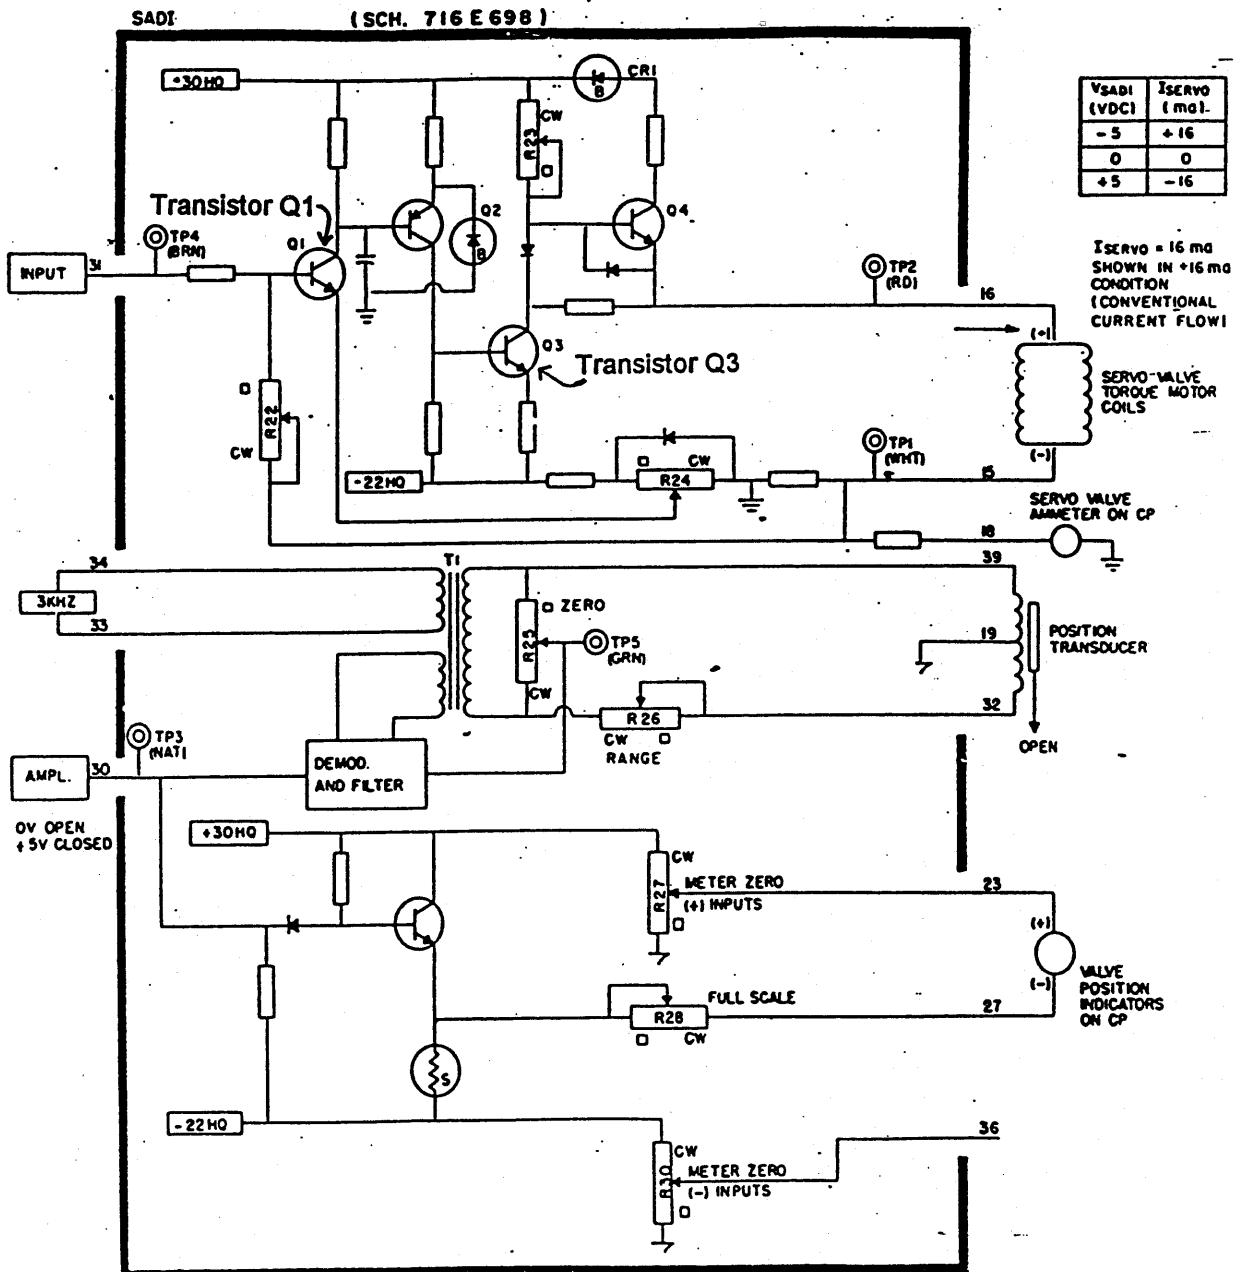
FIGURE 2

The consultant concluded that the most probable cause of the SADI board failure was a failed transistor (Q3) on the board (see Figure 2). Failure of the transistor was intermittent and most likely due to age related degradation. Destructive examination found a small conductive particle loose inside the transistor. This loose particle is considered the most likely cause of the failed transistor. The electromagnetic field created during energization of the transistor probably attracted the loose particle to the base-collector junction causing a short circuit and signal failure similar to the one observed during troubleshooting after the trip. Computer modeling and actual shorting of the collector to the base were utilized to verify the behavior of the circuit. The behavior of the circuit with a collector-base short circuit was verified to be very similar to the observed behavior of the SADI board during troubleshooting.

Examination of other transistors on the SADI board revealed signs of manufacturing defects and/or age related degradation. The consultant also observed that the SADI board was in good overall condition and very well constructed with the highest quality components available at the time of production. The SADI boards components, with the exception of the problems noted with the transistors, were not considered susceptible to similar wearout mechanisms. Both the turbine vendor and an independent consultant who is performing an analysis of our Turbine EHC Systems to identify improvements have stated that the large population of similar boards in service at fossil and nuclear facilities have been very reliable.

- Replaced the failed SADI board.
- Performed component level checks on the other SADIs in Turbine EHC Cabinet 1T11.
- Replaced failed fans in EHC Cabinet 1T11.
- Repaired all minor deficiencies discovered during troubleshooting activities.
- Sampled the turbine EHC fluid to ensure it was clean.
- Performed a non-destructive failure analysis of the SADI board and servo valve for MTSV-2 to determine any obvious failure mechanisms prior to sending the parts to vendor for a more complete analysis.
